Operation **TEAPOT**

Project 31.2

**DAMAGE TO COMMERCIAL AND INDUSTRIAL BUILDINGS
EXPOSED TO NUCLEAR EFFECTS**

Report to the Test Director

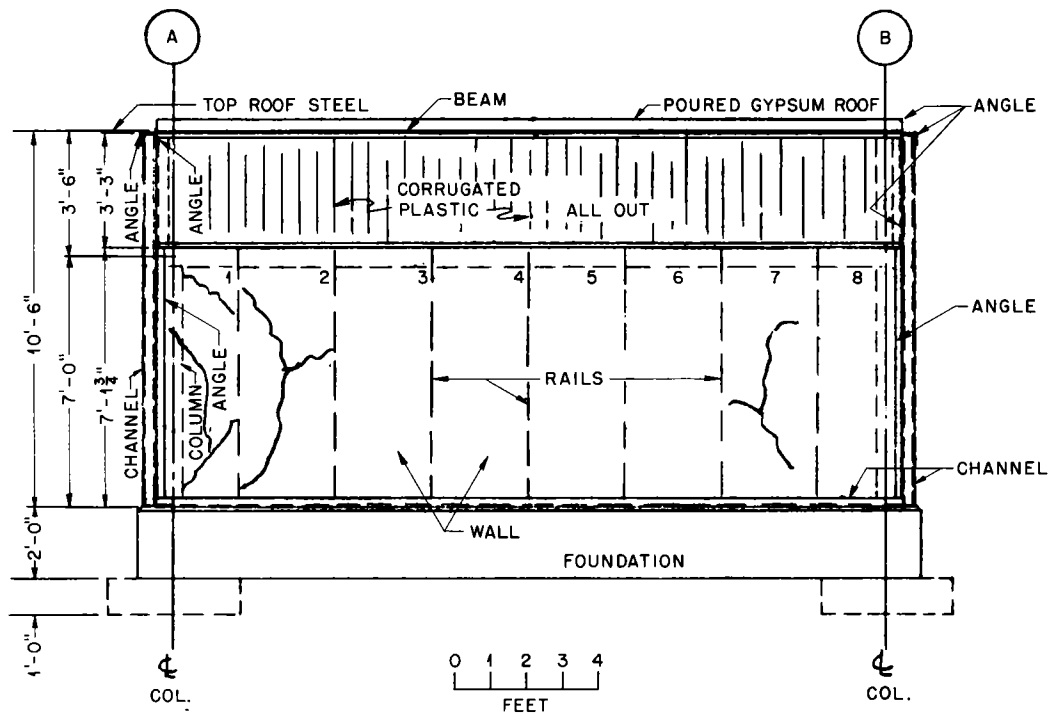
Fig. 1.3—Front elevation of Union Carbide building.

The reinforced-gypsum walls suffered only slight damage. The wall facing the blast (Fig. 1.3) showed moment cracks on the interior surface. These cracks were a maximum of $\frac{1}{32}$ in. in width, and they occurred in three of the panels formed by the vertical steel rail studs. The south wall, away from the blast center (Fig. 1.4), developed a horizontal crack approximately $\frac{1}{16}$ in. in width, starting near the southeast building column and extending across one-third of the bay. The east and west walls showed no moment cracks, but several shear cracks developed in the west wall at the top of the panels at roof level near the door opening, as shown in Figs. 1.6 and 2.16.

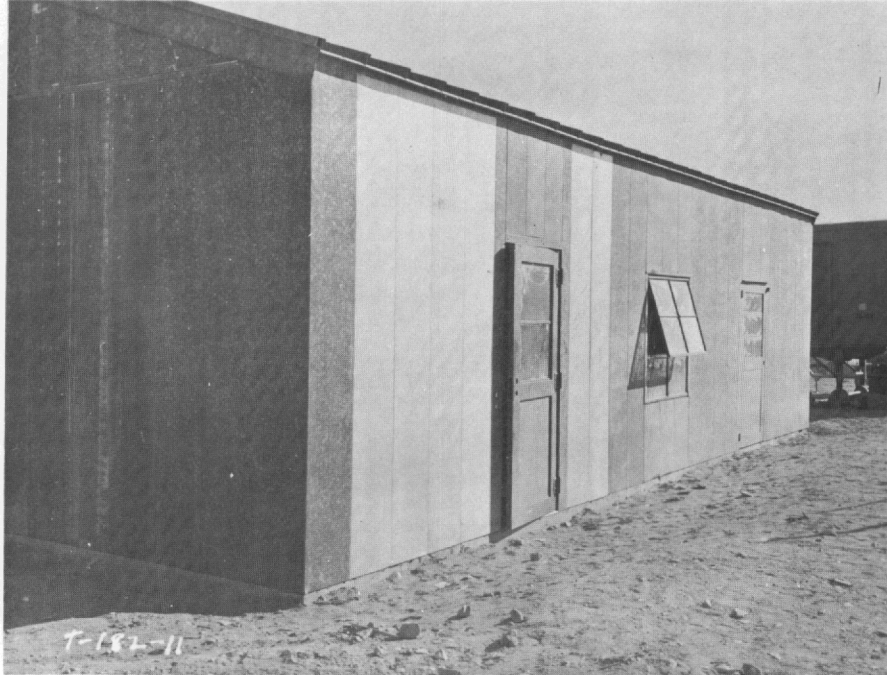
Fig. 1.22—Armco Building 31.2-d1 repaired after unexpected test.

after repair of the north wall damage, was previously illustrated in Fig. 1.22. Appendix B provides an analysis of the dynamic behavior of Building 31.2-d1.

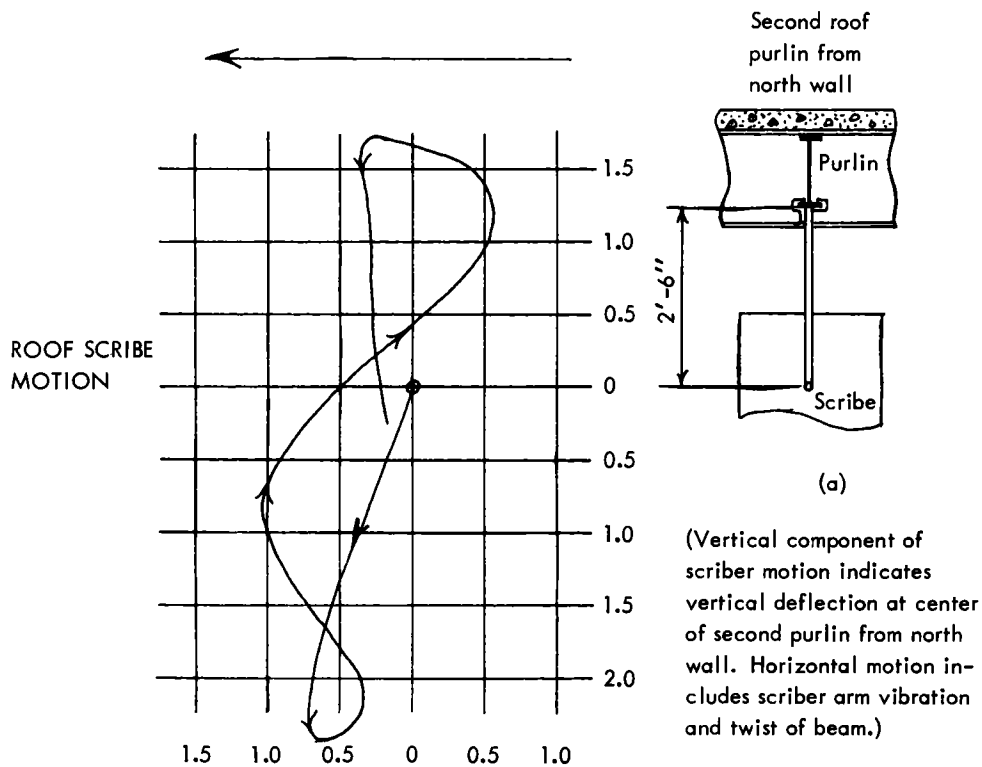
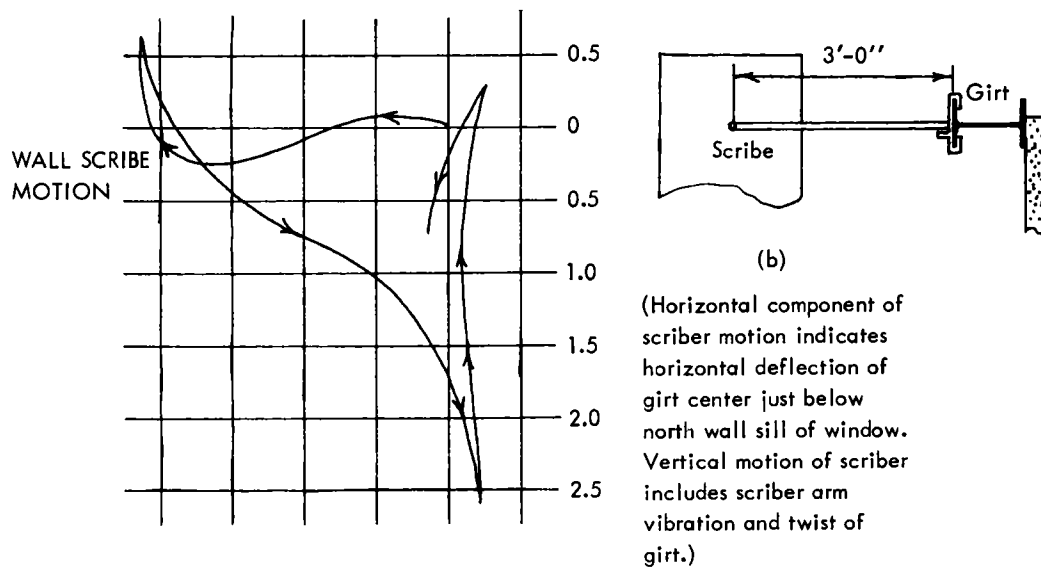
Fig. 2.14—Deflections of roof and north wall in Union Carbide building during planned test.

Severe vertical roof movements were indicated on scratchboards, and these movements are recorded in Fig. 2.14 at the one available location. No permanent deflections were recorded for any roof beams, except for the beam one panel from the south wall, which had a permanent upward deflection of $\frac{1}{8}$ in. at the center of the beam.

1. Horizontal girt in north wall: torsion and horizontal deflections, as shown in Fig. 2.14.
2. Roof girder at east wall: torsion in the girder, as shown by the impact mark on the scratchboard by the stylus pipe arm.
3. Roof beam, just north of center line: vertical displacement coupled with some torsional movement, as shown in Fig. 2.14.
4. Column in southeast corner (near girder): displacement approximately $\frac{1}{4}$ in. in north and south directions.

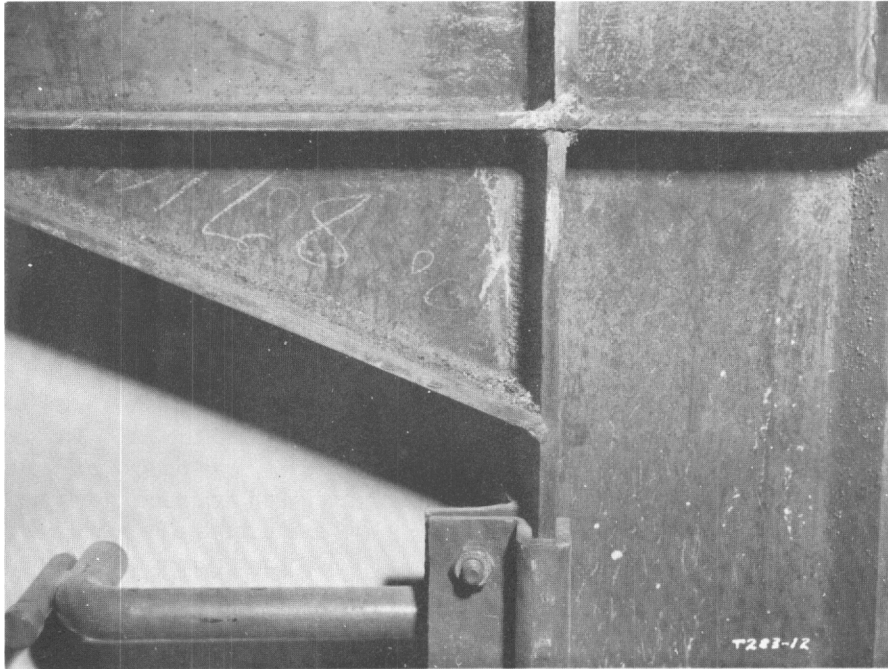
Fig. 2.15 — Southeast corner frame connection of Union Carbide building.

None of the steel details or welded connections showed any serious indication of yielding or failure. Figure 2.15 shows the typical condition of a welded detail at the main frame connection after the test.

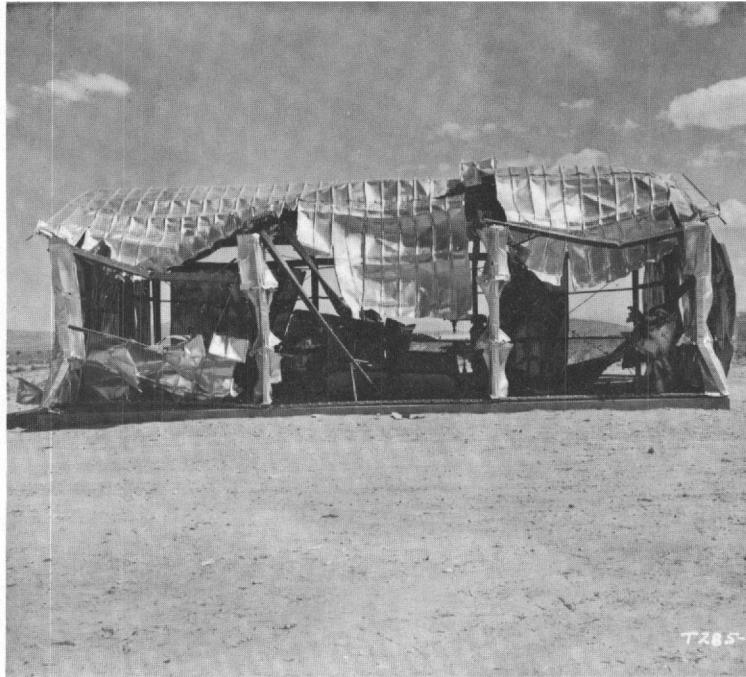
Fig. 2.17 — North side of Reynolds-Butler Building 31.2-a1 after planned test.

In addition, the two end frames at the north corners were bowed laterally inward, a distance of about 11 in. at each end, toward the center of the building. This inward deflection is quite noticeable in the general view of the north side, as shown in Fig. 2.17. The unbalanced tension in the girts at the ends, as well as the inward pressure, was undoubtedly a factor contributing to this inward movement. In addition, the girts showed evidence of having hung on the corner columns longer than on the interior columns, thus exerting a twisting and pulling action accentuated by drag on the crumpled mass of sheeting that remained attached to these girts.

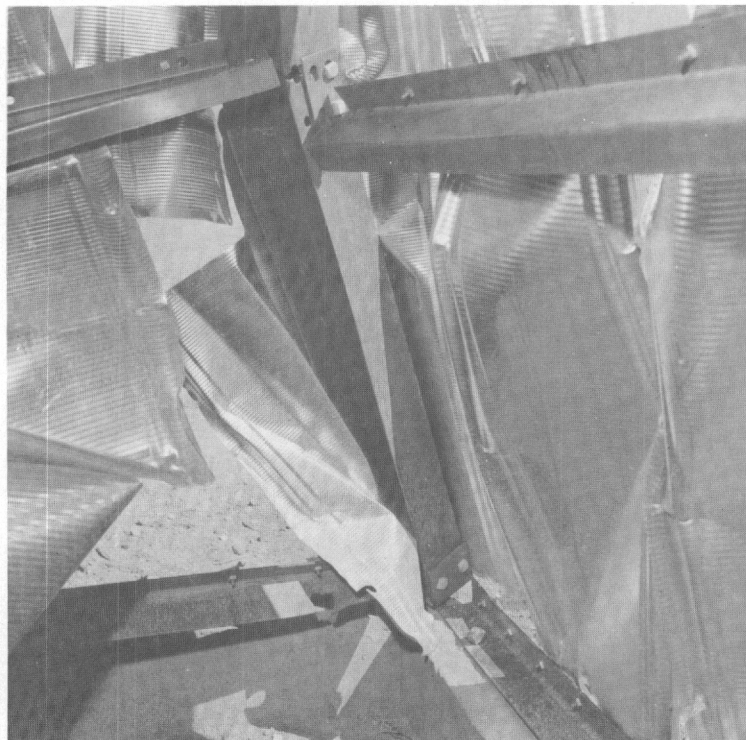
The columns, as a result of biaxial bending inward, experienced fractures at the bolt holes at the level of the lower girts. The local bent, twisted, buckled, and fractured condition at these details is shown in Figs. 2.18 and 2.19 for the northeast and northwest columns, respectively.

Fig. 2.18 — Interior detail of northeast column in Reynolds-Butler Building 31.2-a1 after planned test.

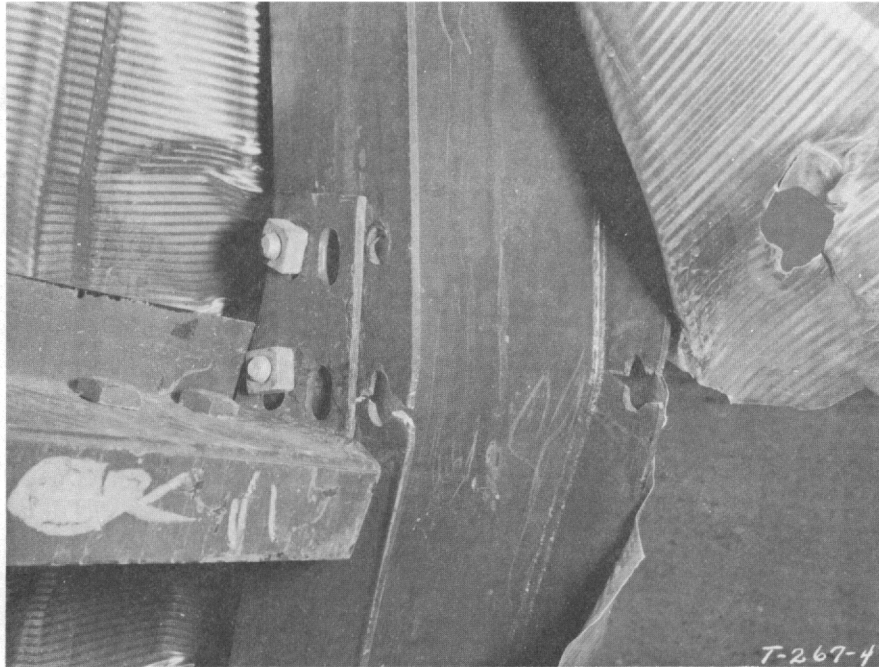
Fig. 2.19 — Interior detail of northwest column in Reynolds-Butler Building 31.2-a1 after planned test.

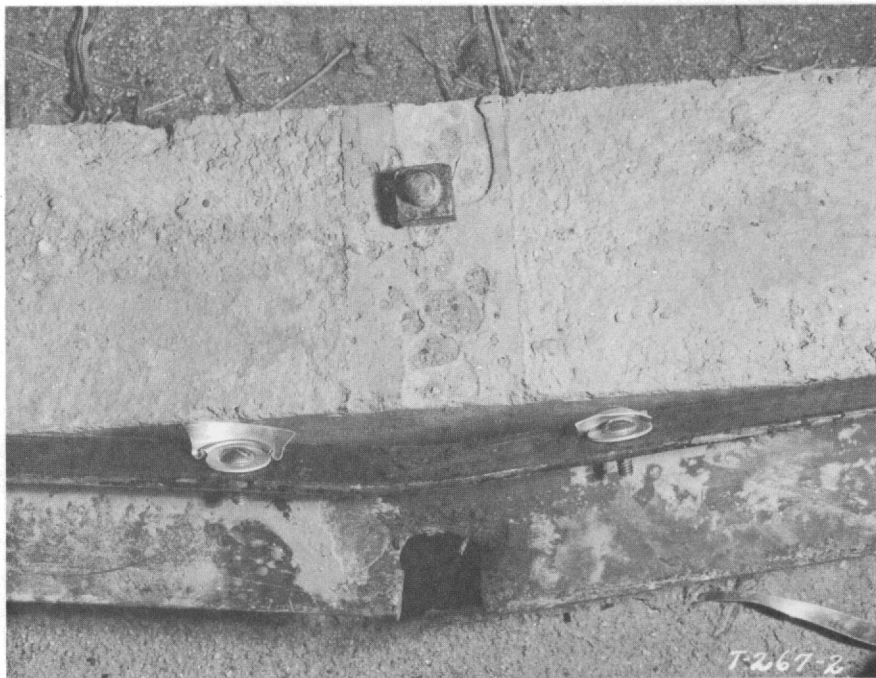
From the base of the wall sill to the ridge of the roof, the wall or roof paneling in each of the three spaces between bents was supported successively by a sill angle, two Z girts, a channel eave member, and four Z purlins, as shown in Fig. 1.11. Along the north wall the sill angles originally attached to the wall footing by three bolts were all torn loose from their center bolts, and at the east end the sill angle remained attached to the west bolt only. Figure 2.20 shows one of the bent and twisted sill angles and also illustrates how the paneling was torn completely loose from its bolt and washer fasteners.

Fig. 2.20 — View looking down on sill angle in Reynolds-Butler Building 31.2-a1 after planned test.

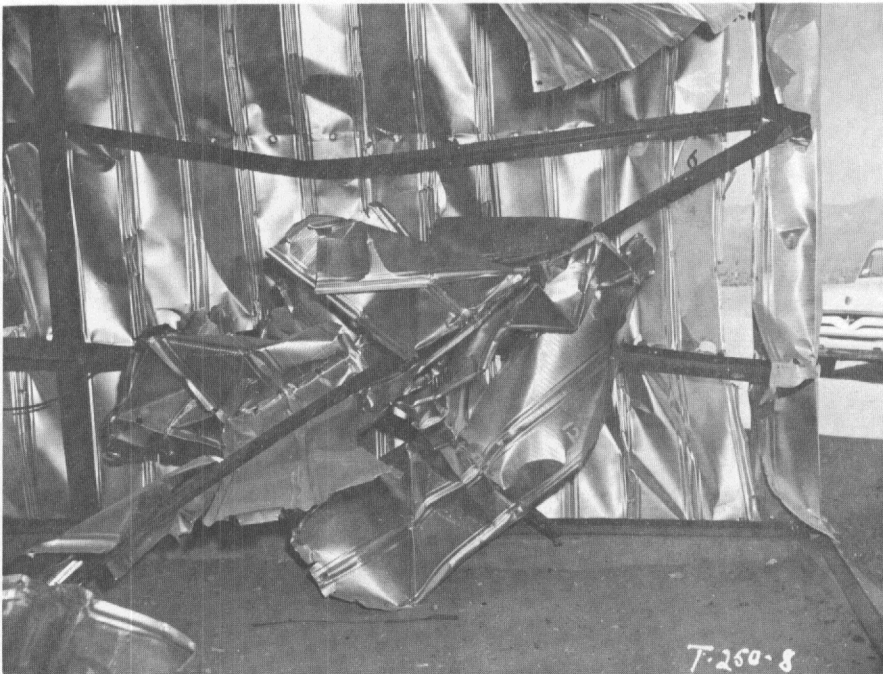
Of the six girts on the north wall of the building, five were torn off at the ends in the manner shown in Fig. 2.21. The upper girt at the west end remained attached to the corner column, providing the hinge about which the two girts and the crumpled mass of sheeting swung inward toward the west end of the building, as illustrated in Fig. 2.22. Of the three north wall eave members, each was torn loose at one end and remained attached at the other end. The east eave strut was bent into a V shape with about a 3-ft center deflection. The west end of the center eave strut, after tearing loose, swung down to the ground.

Fig. 2.22 — Interior view of Reynolds-Butler Building 31.2-a1 after planned test. (Note that west girts and panels of north wall have been thrown against west end.)

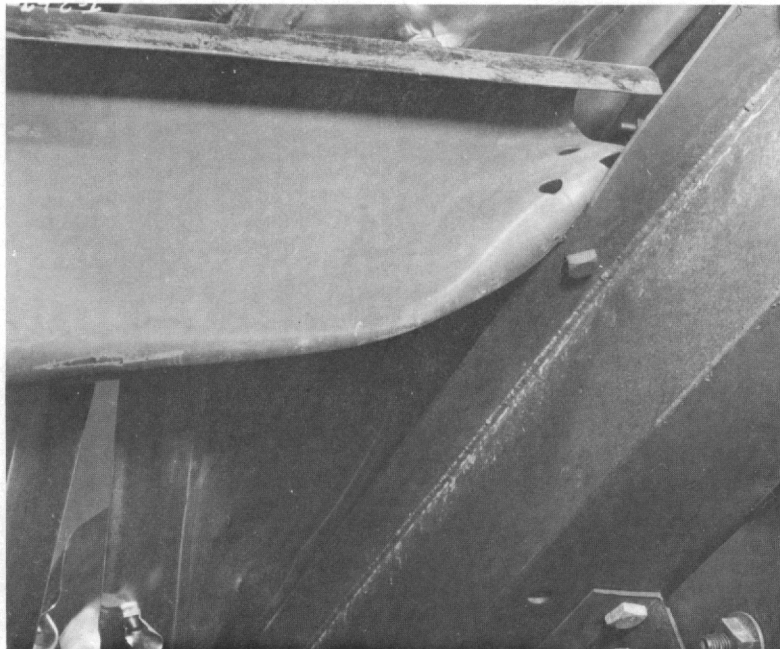
The purlins on the north slope of the roof will be discussed in groups of four each, in the east, center, and west bent spaces, respectively. Figure 2.23, a view looking up at the east space, shows the purlins still attached to the frames at each end, but with their ends crippled and the purlins twisted and bent, especially in the case of the two nearest the eave member. Figure 2.24 is a closer view of the end crippling of these purlins. Roof sheeting was still attached to the ridge purlin and the adjacent purlin, but the sheeting was torn loose from the two lower purlins. In the north central space the purlin nearest the eave member was torn loose at the west end, coming to rest on the ground along with the eave member, but the three upper purlins were still hanging to their bolted end connections with the roof sheeting draped loosely over them, attached only to the ridge purlins. In the west space the two central purlins were torn loose from their east connections, but they were prevented from falling by the wind-bracing rods in the plane of the roof, as shown in Fig. 2.25.

Fig. 2.24—End crippling of purlins at northeast corner of Reynolds-Butler Building 31.2-a1 after planned test.

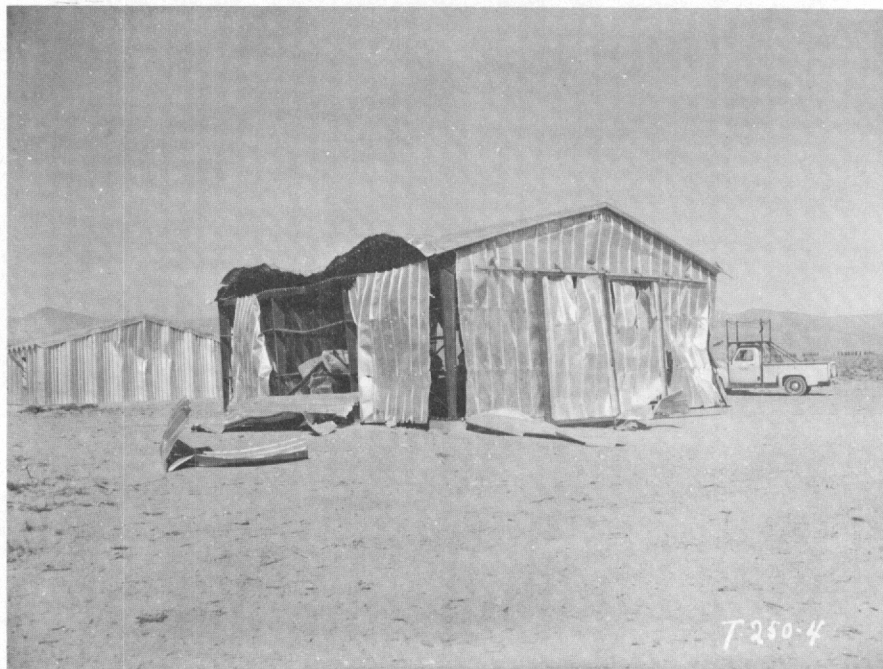
On the south wall the sheeting was all detached from girt fasteners, except for two segments that remained hanging along their top attachment to the eave members (Fig. 2.26). All the girts on the south side remained attached at their end connections to the main frames, as

Fig. 2.26 — South side and east end of Reynolds-Butler Building 31.2-a1 after planned test.

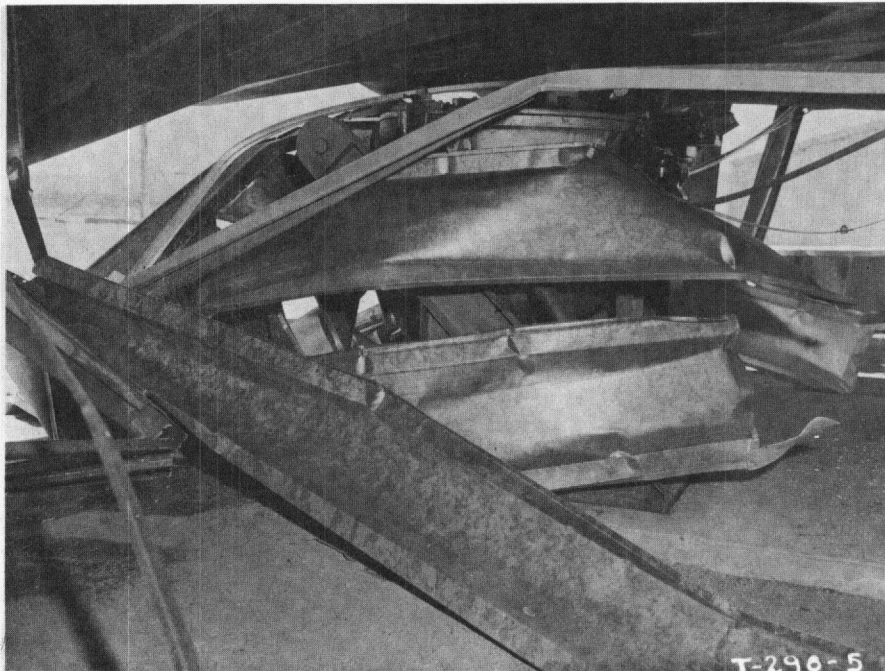
Fig. 2.45—Interior view of Armco Building 31.2-d1, showing front paneling draped around machinery after planned test.

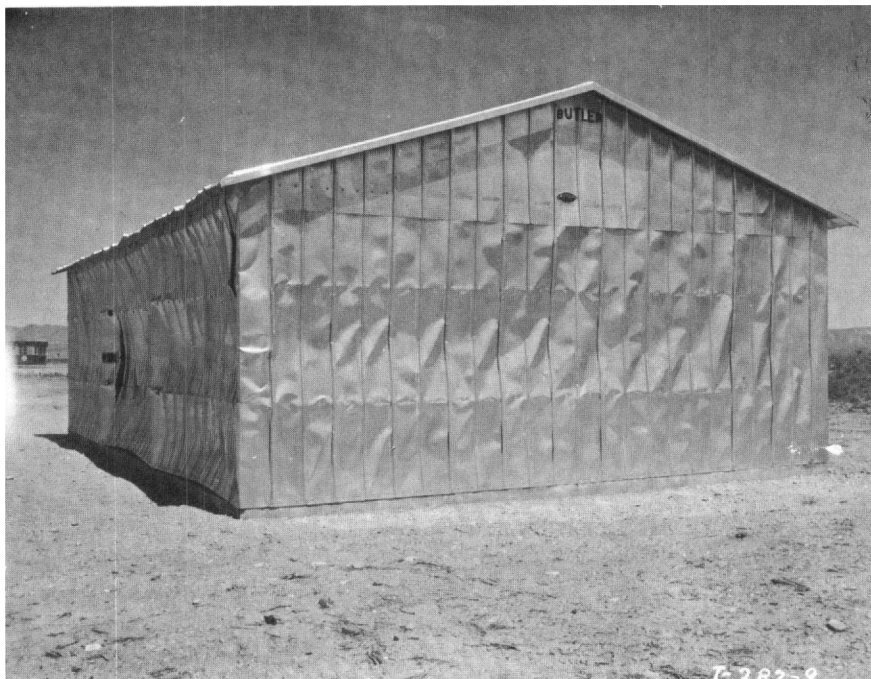
Fig. 2.48 — West end of Reynolds-Butler Building 31.2-a2 after planned test.

A general description of these buildings is given in Sec. 1.3.2, and general drawings, are shown in Figs. 1.10 and 1.11. Over-all behavior during the unexpected test is described in Secs. 2.1.2 and 2.1.3, and behavior during the planned test is described in Secs. 2.2.3 and 2.2.6. Figure 2.1 shows the wall after the unexpected test, and Fig. 2.2 records the measured offsets of permanent wall deflection after both the unexpected and planned tests. Figures 2.3 to 2.5 show other views of damage to the walls and roof which resulted from the unexpected tests, and Figs. 2.46, 2.48, and 2.49 show the wall condition after the planned test at the 15,000-ft line.

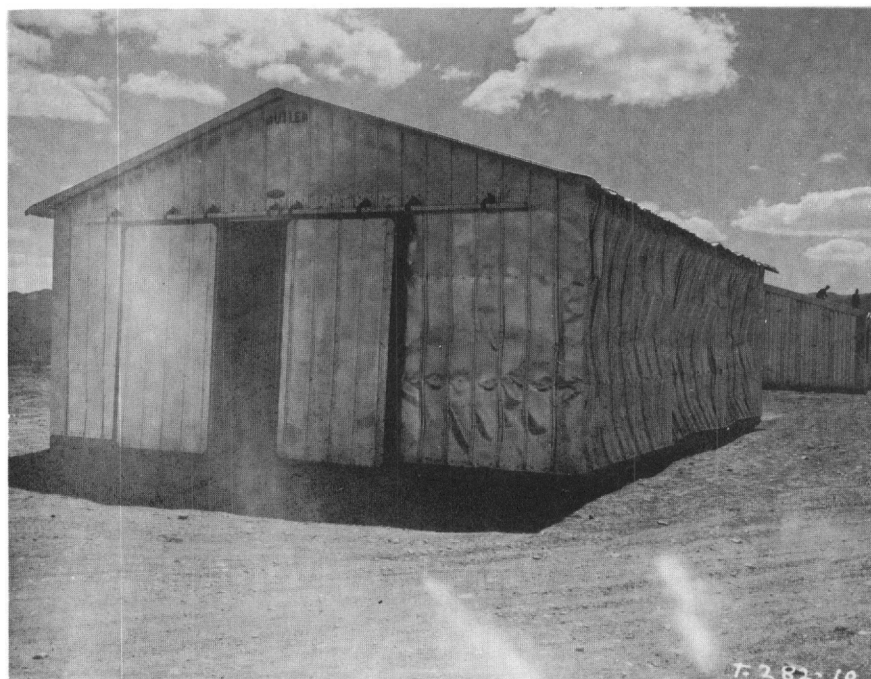
Fig. 2.49 — East end of Reynolds-Butler Building 31.2-a2 after planned test.

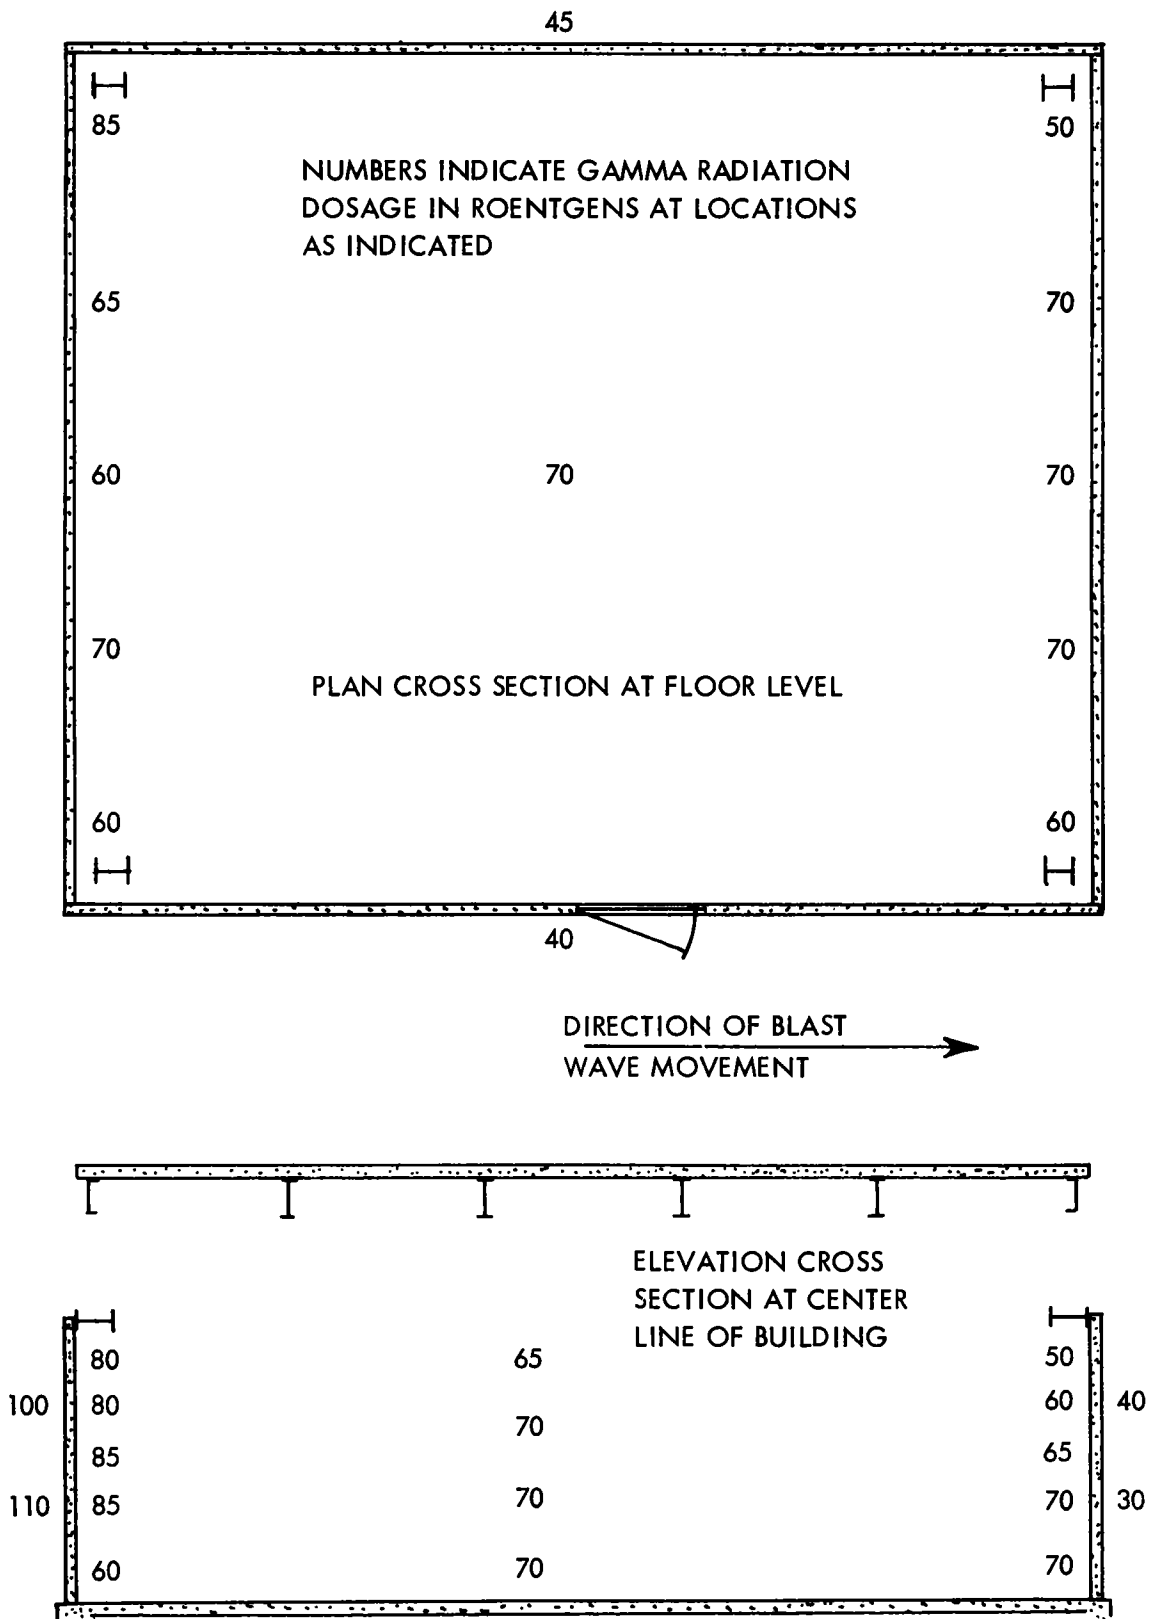
Fig. 2.54—Gamma radiation measurements in Union Carbide building.

In the case of the Union Carbide building at 5500 ft, with 4-in. reinforced-gypsum walls, there were significant variations in film-badge readings. A vertical cross section running north and south at the center line of this building and a horizontal cross section at floor level are shown in Fig. 2.54. The only reading not recorded in Fig. 2.54 is one on the outside center line of the east wall at about mid-height of the building which gave a reading of 80 r. The gauge near ground level at the same location had a reading of 45 r, as shown. The reduction in radiation levels behind the structure, as compared with those in front of the structure, is quite significant.

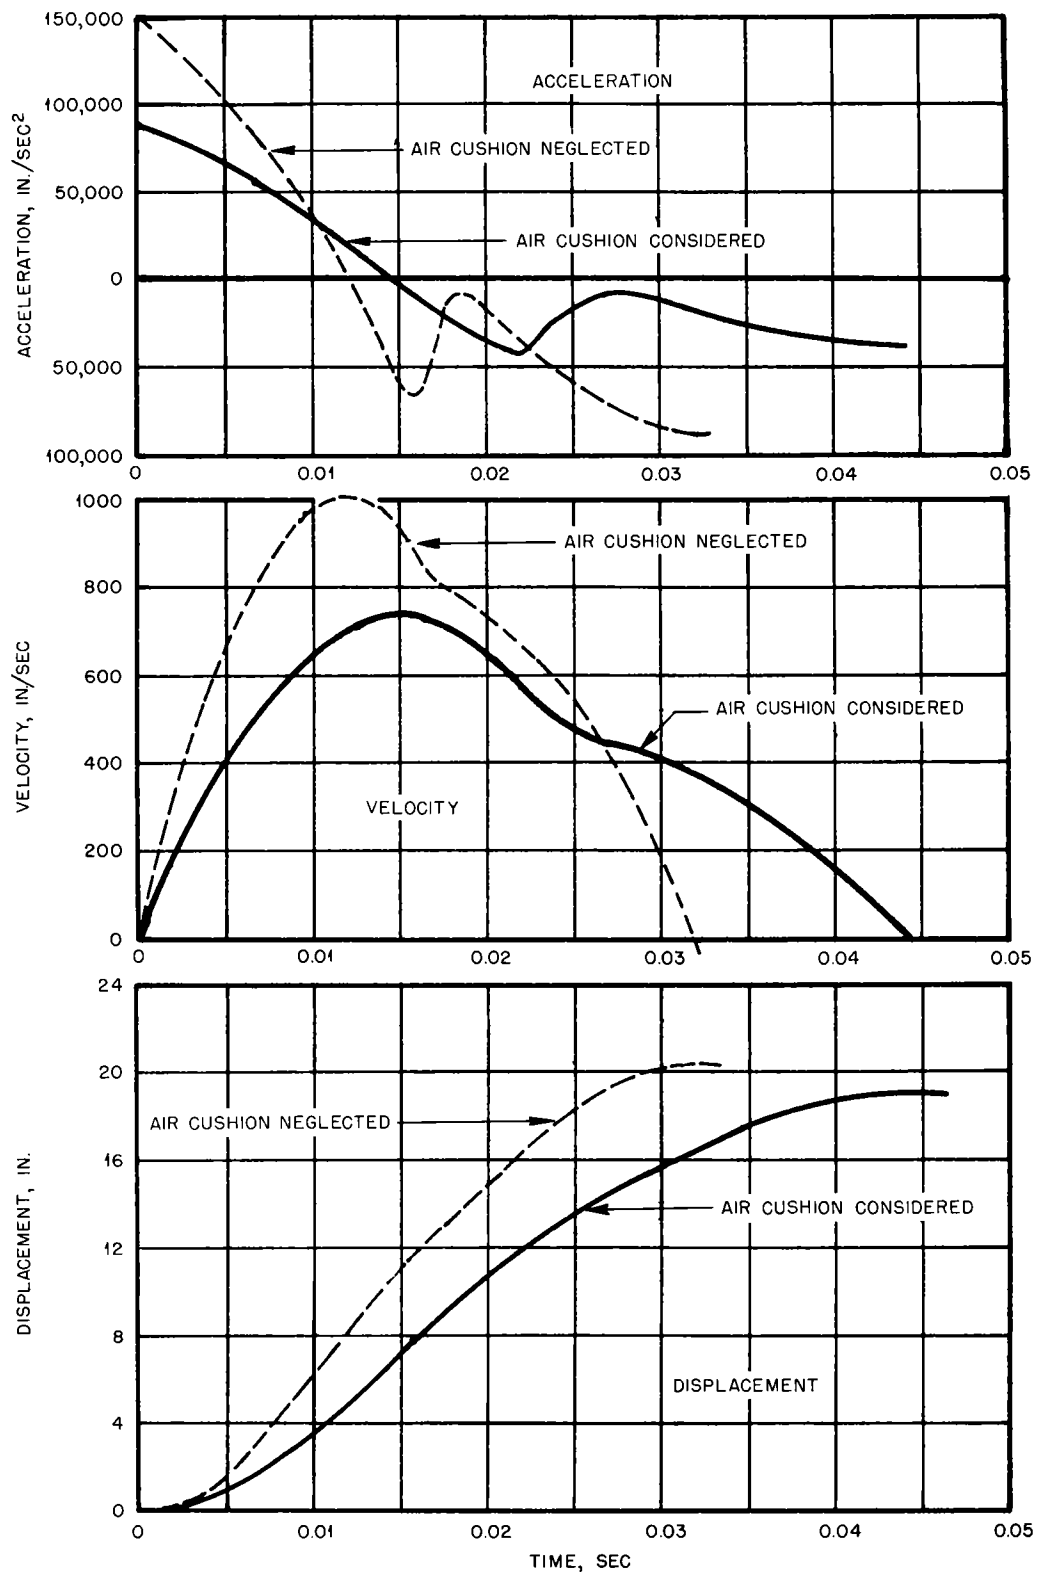
resistance in column 4, the procedure is repeated for the next time interval. If the calculated resistance is different from the trial value, it is introduced as a new trial value in column 4, and the operation is repeated, which will usually give a good check on the second trial. The acceleration, velocity, and deflection at the center of the girt as given in Table A.4 are also plotted in Fig. A.6 as the solid lines. Also shown in Fig. A.6, as dashed lines, are the acceleration, velocity, and displacement calculated without considering the effect of air cushioning. It is to be noted that a considerable difference is obtained in all three curves, but it is also interesting to note that the very appreciable change in mass and the corresponding acceleration introduced by the air-cushion effect results, finally, in very little difference in the calculated maximum displacement, i.e., 20.4 in. when the air cushion is neglected and 19.4 in.

Fig. A.6— Calculated acceleration, velocity, and displacement at center of girt in center wall panel of Reynolds-Butler Building 31.2-a2 in planned test at 15,000 ft.

when the air cushion is considered. As shown in Fig. 2.2, the actual permanent girt deflection for these structures is 13.4 in. for the top girt and 16.3 in. for the bottom girt. These permanent deflections should be less than the maximum calculated deflection since there will be some elastic recovery and some reverse load effect during the negative phase.
